INVESTIGATION OF ALLEGED
WATER SUPPLY INTERFERENCE
BY THE GLENCOE
MUNICIPAL WELL NO. 8

THE ONTARIO MINISTRY OF THE ENVIRONMENT
SOUTHWESTERN REGION
Technical Support Section

Blagoje Novakovic

August, 1976
LONDON

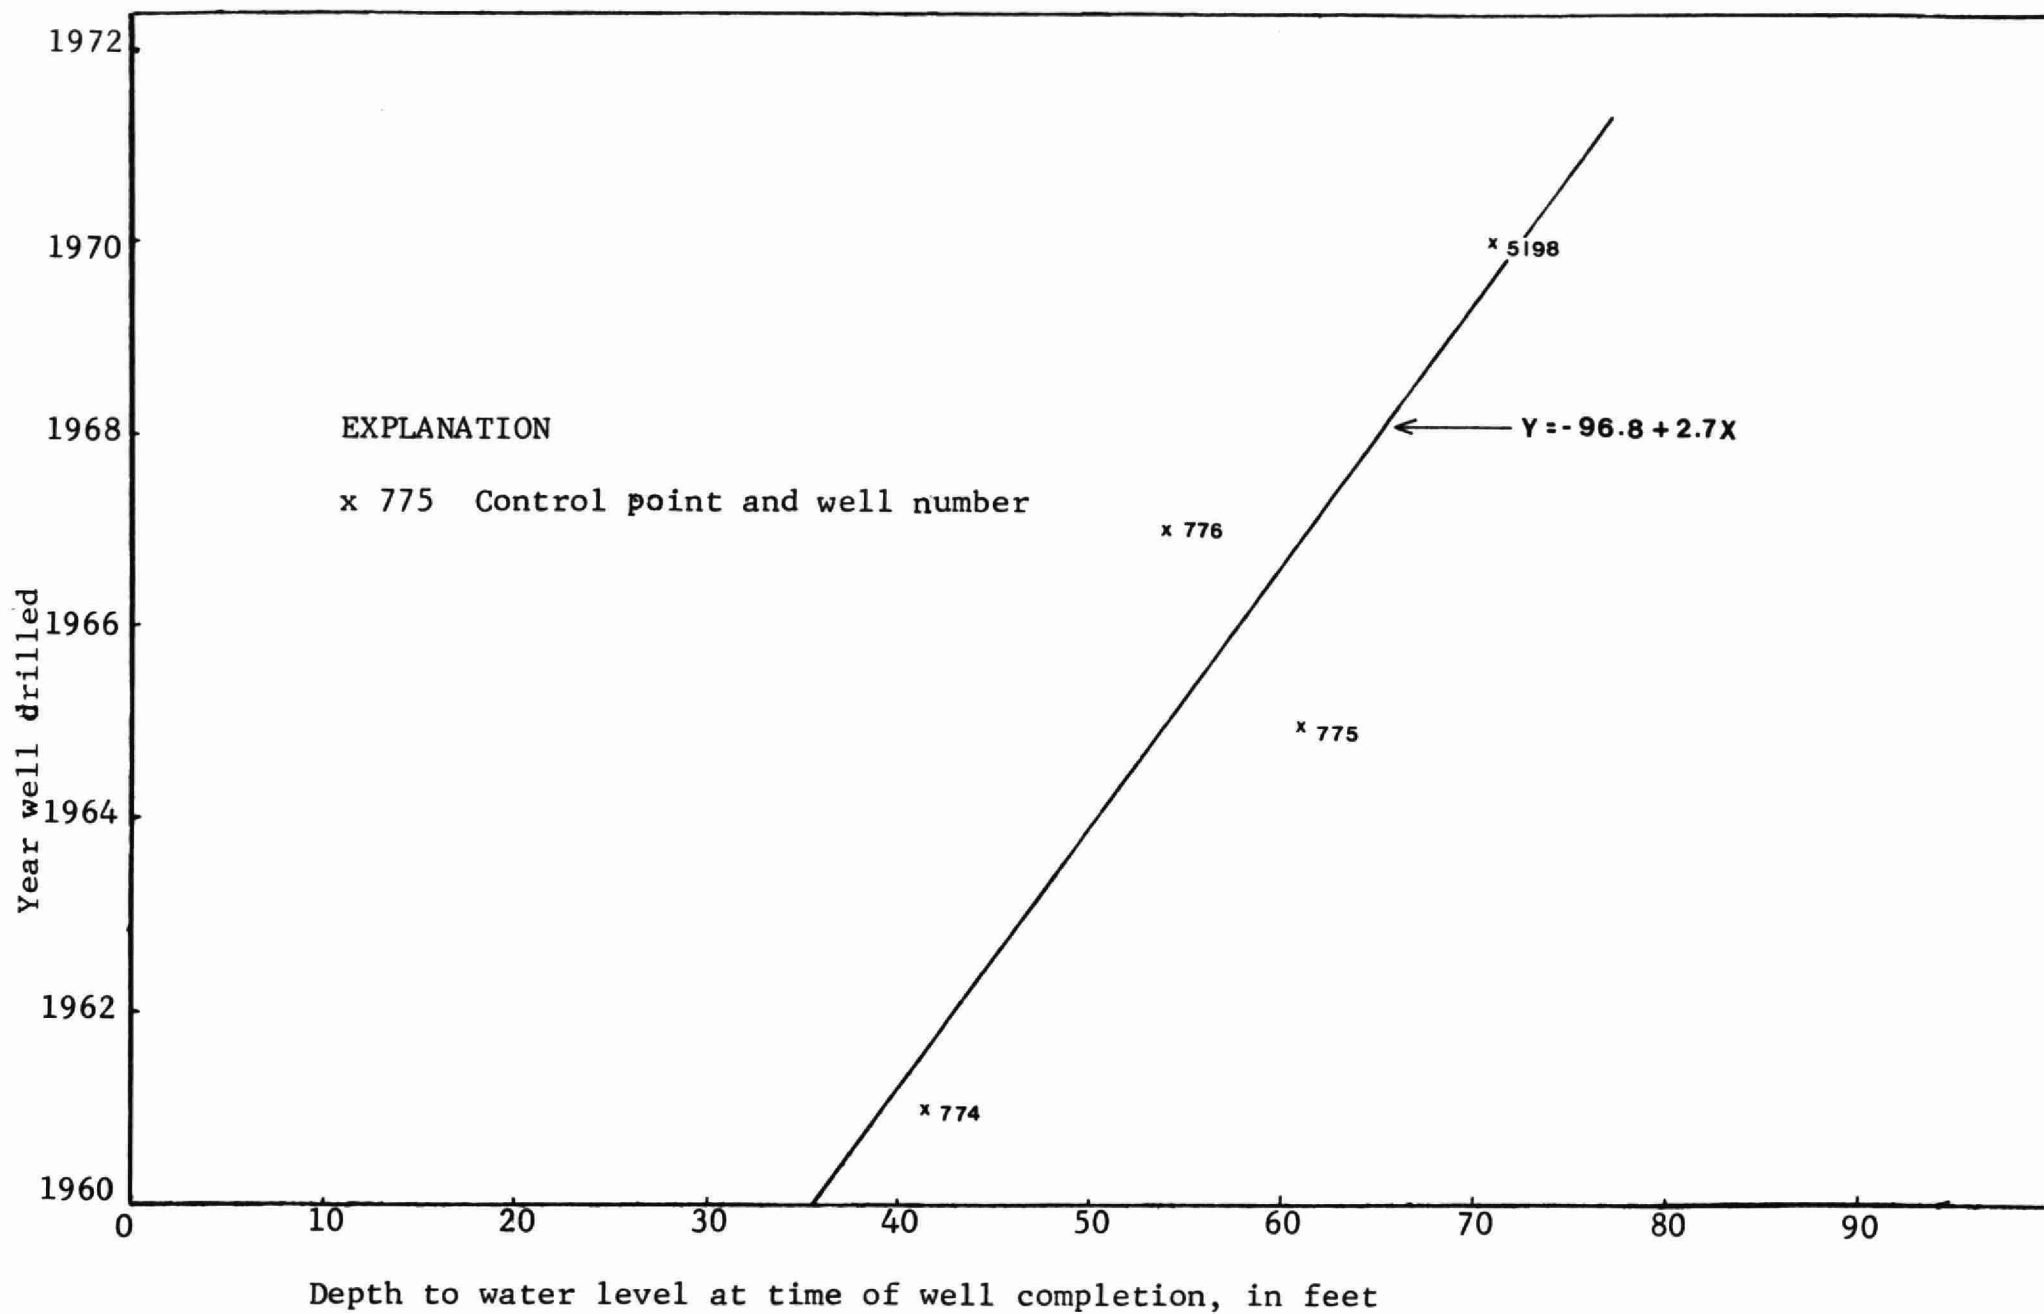
FIGURE 4. SCATTER DIAGRAM OF DEPTH TO WATER LEVEL AND YEAR WELL DRILLED.

A plot of the depths to static water level in the Hadler wells versus the year when the well was drilled, produces a linear correlation (Figure 4). Although, there are only four control points, it suggests that as the groundwater withdrawals increased, the drawdowns also increased with the result that the cone of depression was becoming wider, gaining its "regional" character. Thus, lowering of water level over a larger area and mining of the buried sand and gravel aquifer system became apparent. Mining occurred because groundwater pumpage exceeded natural

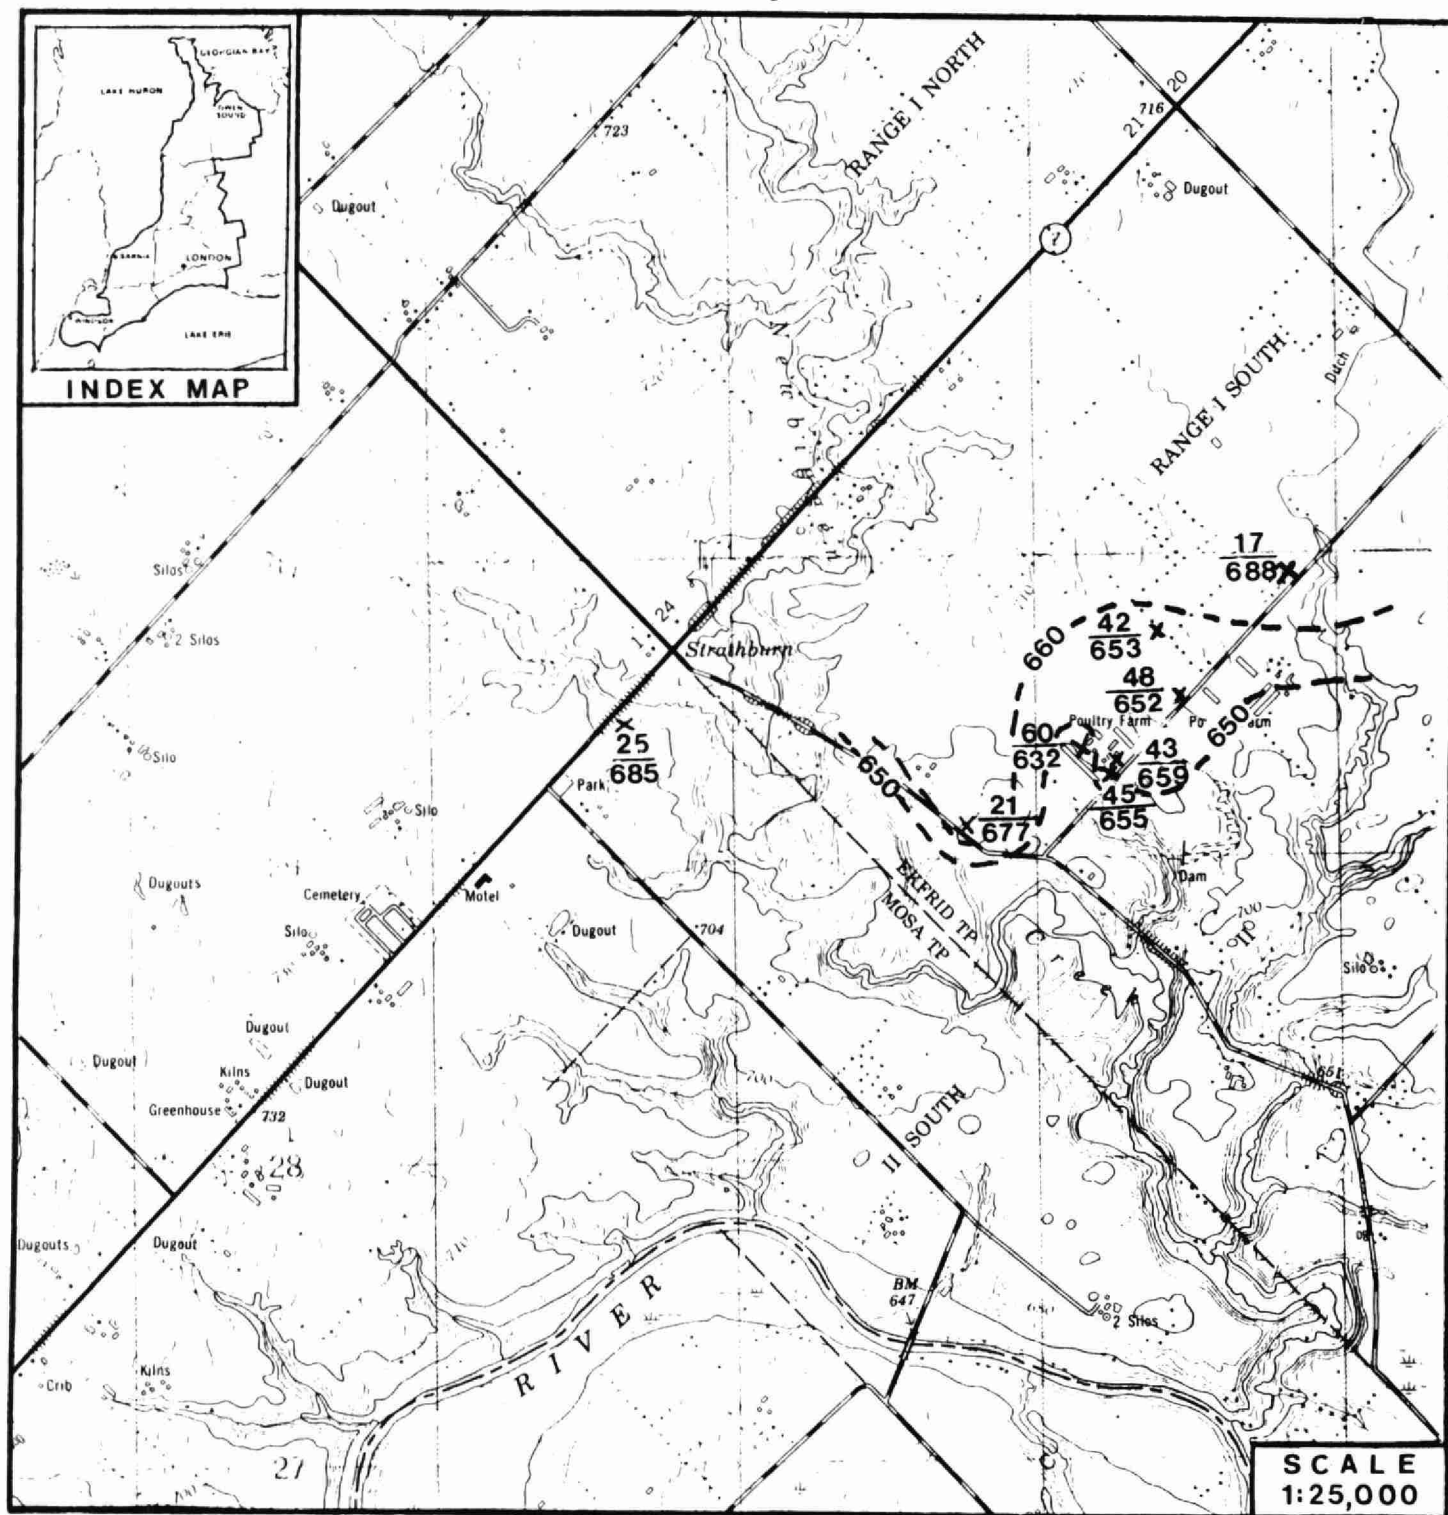
FIGURE 5. RECONSTRUCTED DEPTH TO THE "ORIGINAL" STATIC WATER LEVEL AND PIEZOMETRIC SURFACE OF THE BURIED SAND AND GRAVEL AQUIFER SYSTEM AT THE HADLER TURKEY FARM INC., WELL FIELD.

An attempt has been made to reconstruct the shape of the original piezometric surface of this aquifer system (Figure 5). It shows that the hydraulic gradient of this aquifer was toward Newbiggen Creek which is the area of natural groundwater discharge.

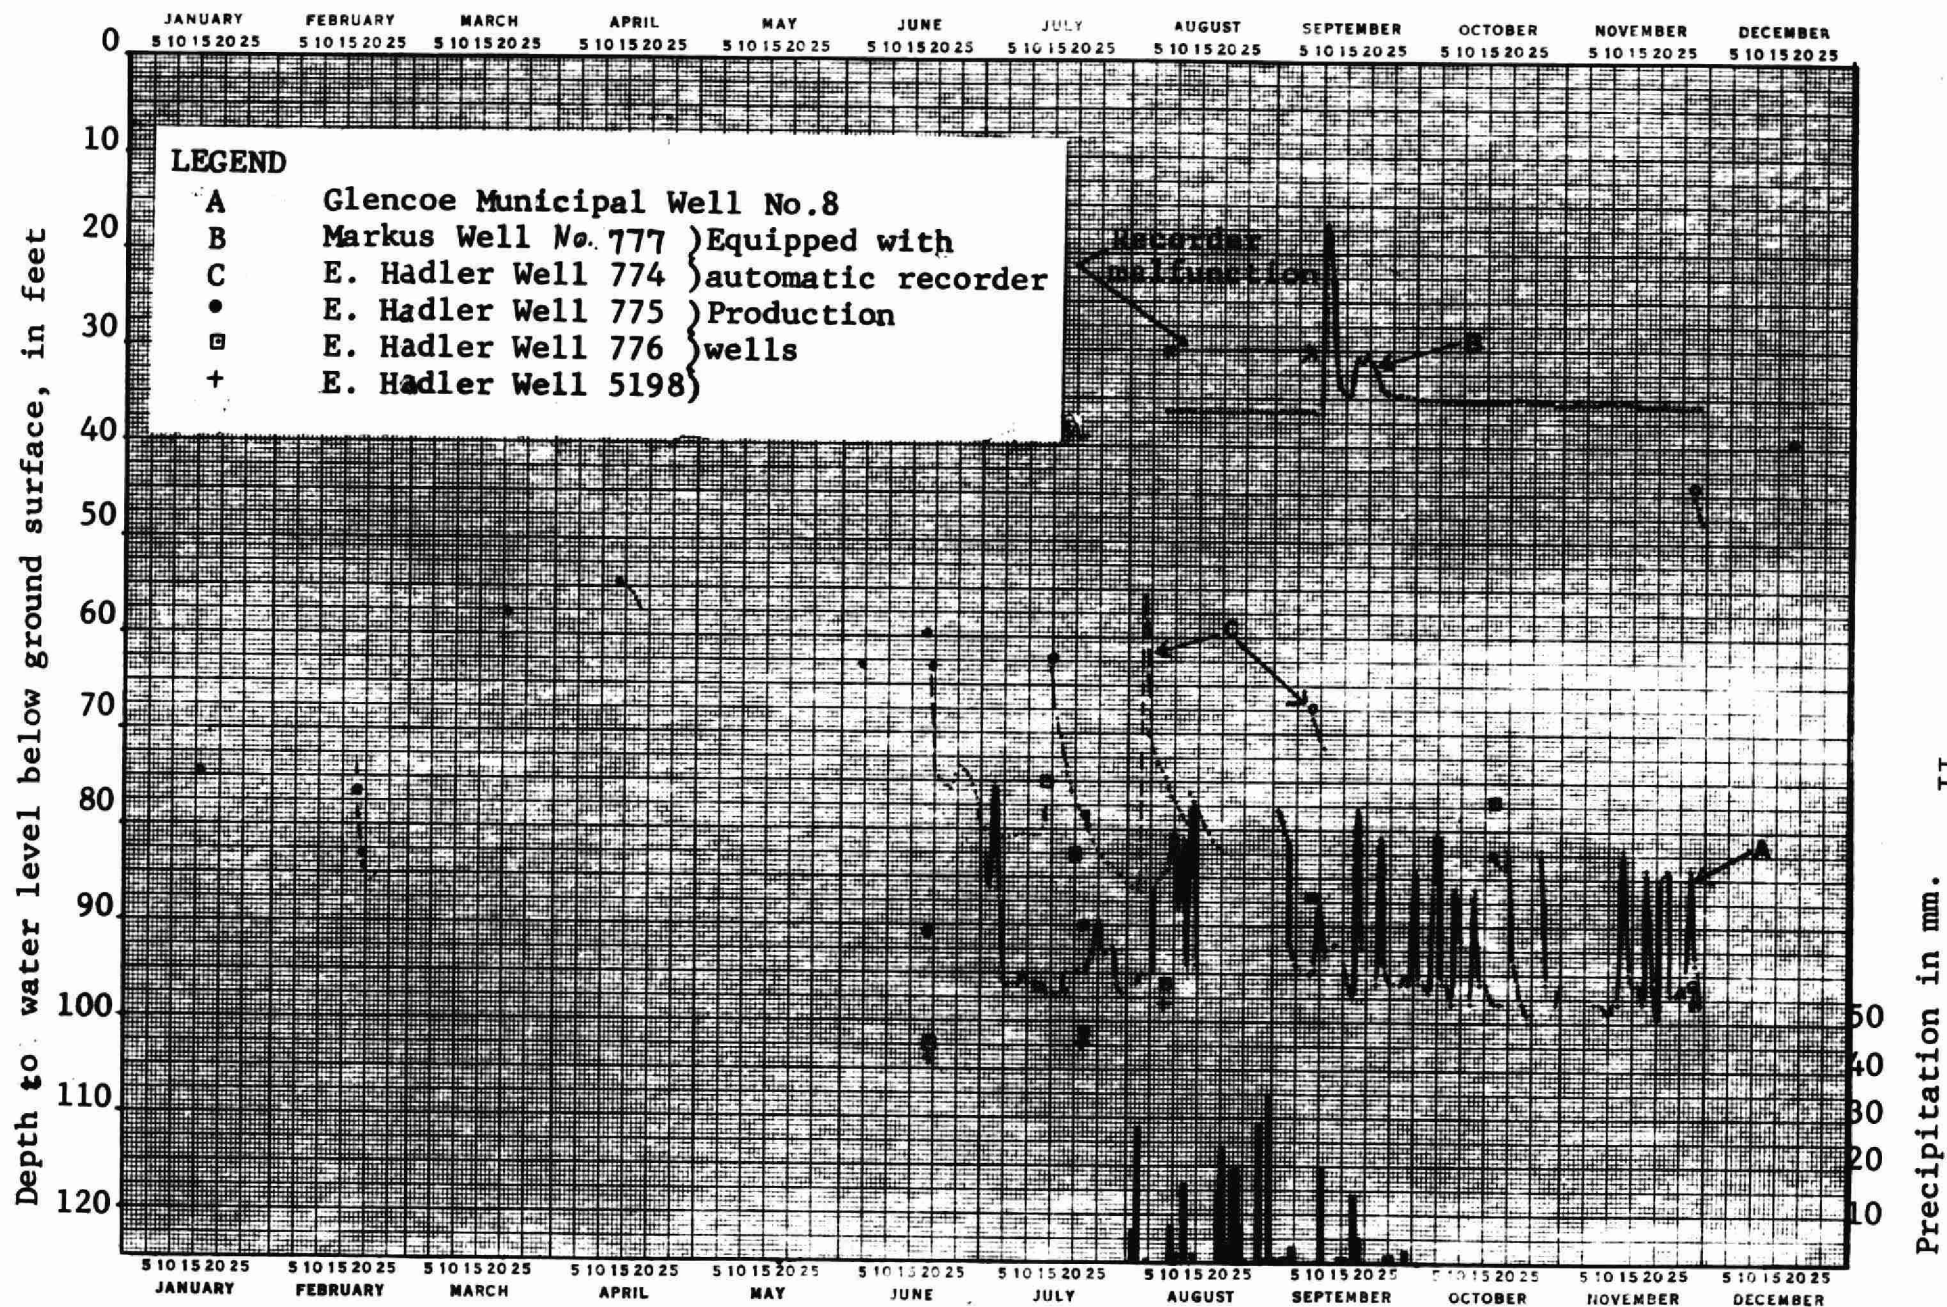
FIGURE 6. WATER LEVEL HYDROGRAPHS AND DEPTHS TO WATER LEVEL.

Measurements in the Hadler production wells during the summer of 1975 revealed water levels between 90 and 105 feet. This depends on how long the pump was in operation before the measurement was taken (Figure 6). Nevertheless, it indicates a sharp decline of the original piezometric surface of the buried sand and gravel aquifer system and the widespread nature of the composite cone of depression (Figure 7). Severe mining of the aquifer is taking place.

The water level in Glencoe municipal well No. 8 remained relatively constant during the summer and fall of 1975 (Figure 6) with the exception of the month of October, when a gentle and gradual water level decline occurred.

For the same time period, the water level in well No. 777 remained essentially the same except for the period between September 11 and 24, 1975 (Figure 6). On September 11, the water level in this well suddenly fluctuated from a stable level of 34 feet to within 17 feet below ground surface. This erratic behavior of the water level continued until September 24, 1975, when relative stabilization was regained.

The erratic behaviour of the water level in well No. 777 may have been caused by (a) direct surface water flow into the well, (b) accelerated aquifer recharge from heavy rainfall or (c) an abrupt stop in production from one or more wells which interferes with this well. It seems unlikely that the two last factors were the cause of the water level rise. Thus the water level rise could be attributed to the direct surface water flow into the well. Glencoe municipal well No. 8 was in production on September 11, 1975, and had average daily groundwater withdrawals of about 20,000 gallons which is an average daily withdrawal for the month of September. Therefore, the possibility that municipal well No. 8 was interfering with well No. 777 is quite remote. There is no information available as to whether any Hadler well was in operation on September 11, 1975, or for how

long. However, the possibility that there is hydraulic communication between the Hadler wells and well No. 777 is not excluded. Field observation showed that the rainfall was responsible for the sudden rise of the water level in well No. 777.

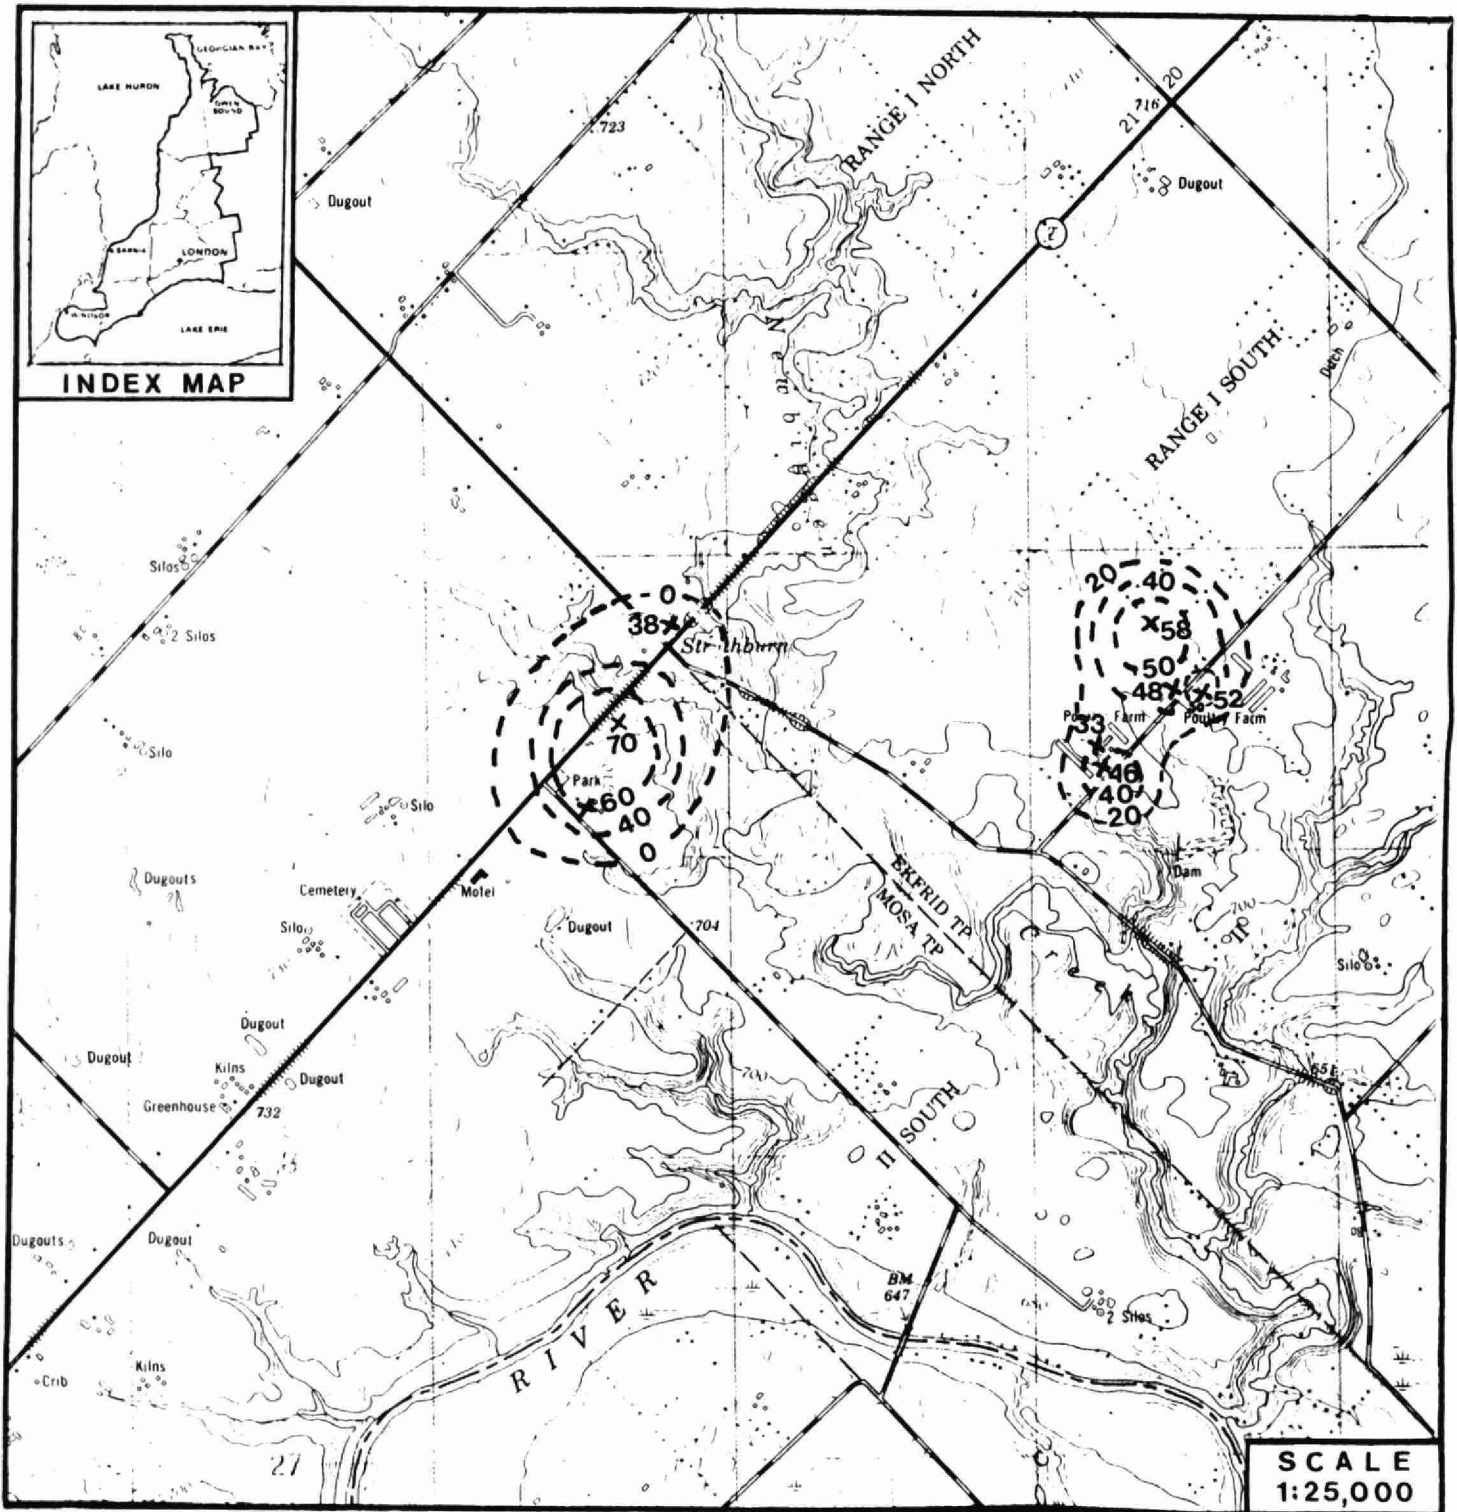
FIGURE 7. CONTOUR MAP OF THE COMPOSITE HYDRAULIC PRESSURE DRAWDOWN OF THE BURIED SAND AND GRAVEL AQUIFER SYSTEM AT THE HADLER TURKEY FARM INC., WELL FIELD (JUNE 19, 1975) AND AT GLENCOE MUNICIPAL WELL No.8. (JULY 22, 1975).

- b) The estimated radius of influence around Glencoe municipal well No. 8 is at a substantial distance from well No. 777 let alone the Hadler well field (Figure 7).

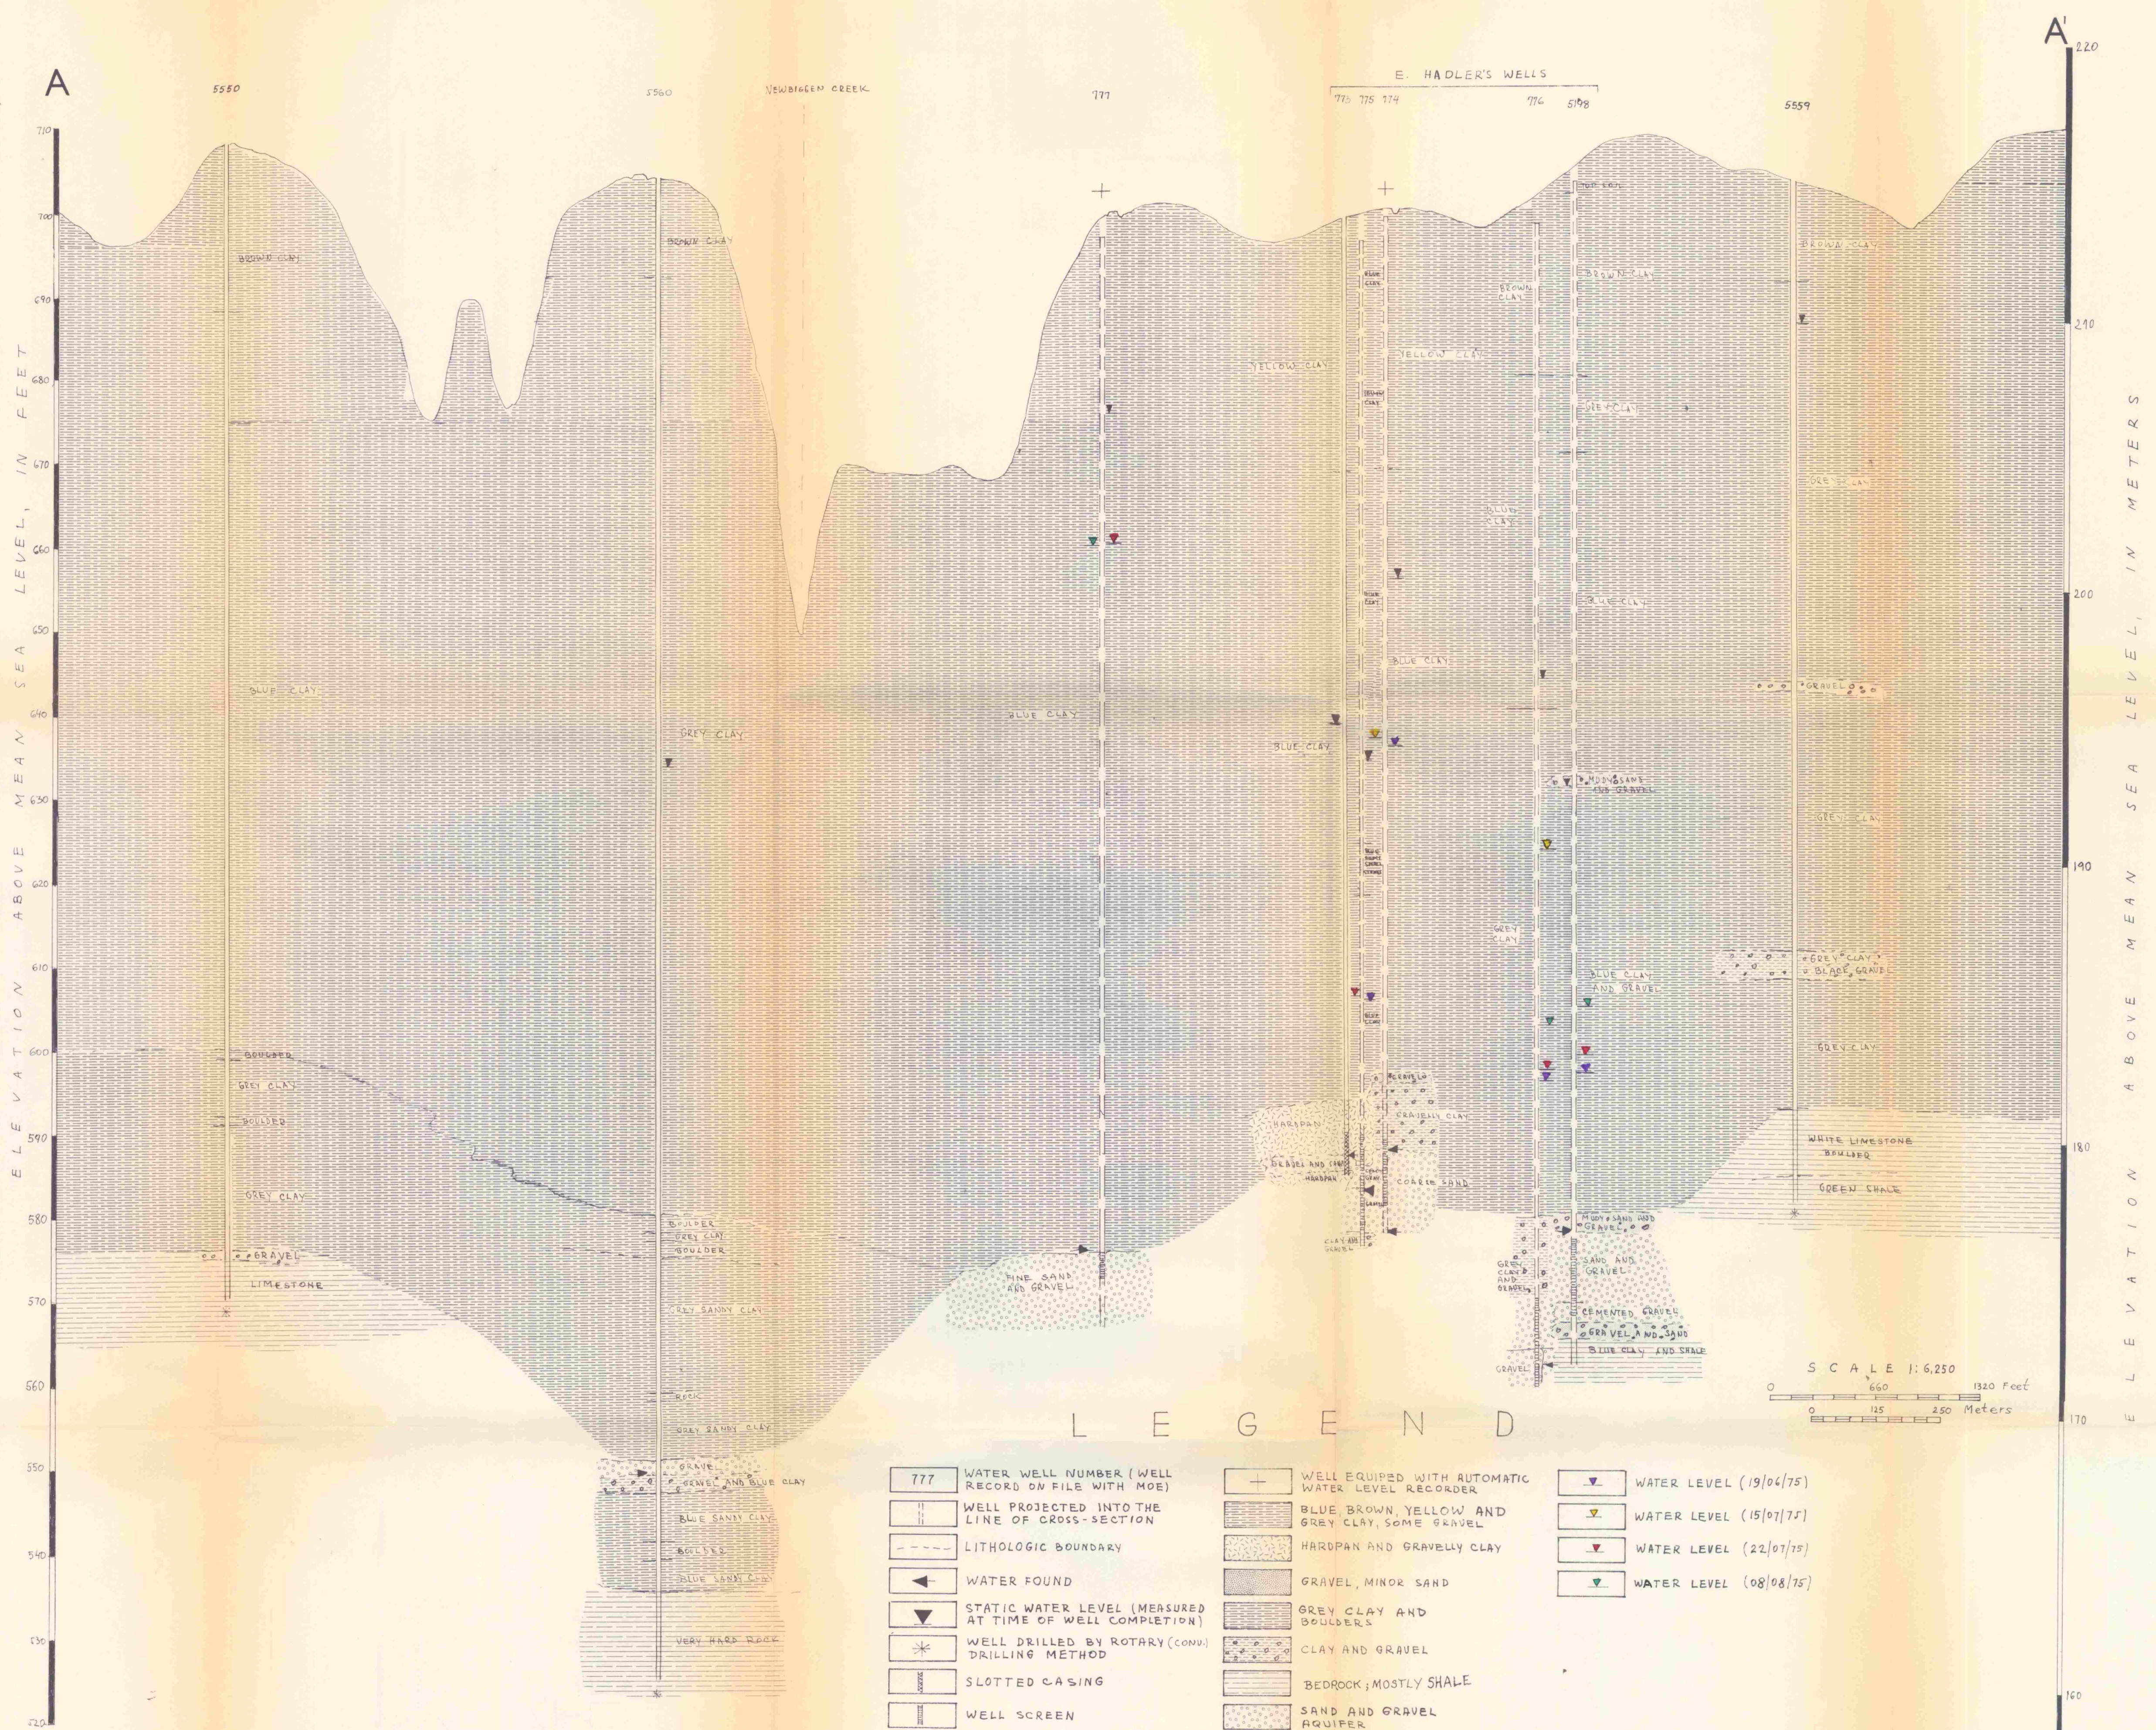
FIGURE 2.

The hydrogeology of the area is delineated by two cross sections shown in Figures 2 and 3. They are based solely on information from water well records. It can be seen from these two cross sections that the water-bearing zone consists of gravel and sand lenses with limited lateral extent and thickness. The thickness of sand and gravel deposits at the Hadler well field does not exceed 10 feet,

while at the municipal well No. 8 gravel and sand deposits had a reported thickness of about 30 feet. This sand and gravel aquifer material is overlain by 110-120 feet of lacustrine clay and hardpan (Figure 2 and 3) which is considered to be an aquitard. The sand and gravel deposits are situated immediately above, or near the bedrock surface.

GEOLOGICAL CROSS SECTION A-A' SHOWING VARIATION OF HYDROGEOLOGICAL ENVIRONMENTS AT THE HADLER TURKEY FARM.
